# Manhole Inspection Summary

Manhole # S31Q\_\_005MH

Insp Date: **12/2/08 1:47 PM**

**Location** Address: **Raven Staduim (Russel St)**

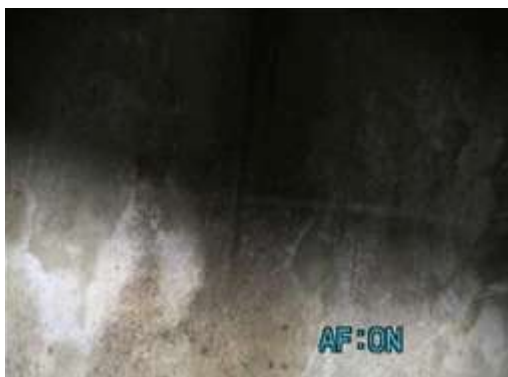
CONDENSATION FROM TOP OF LID

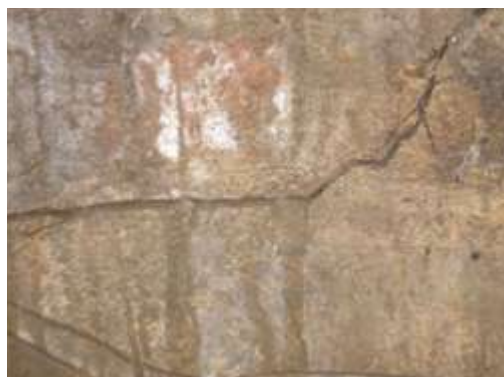
Defect 6

Condition: ☐ Sound ☒ **Cracked** ☐ Root Intrusion ☐ Loose Brick ☐ Deteriorated

cracked corbel

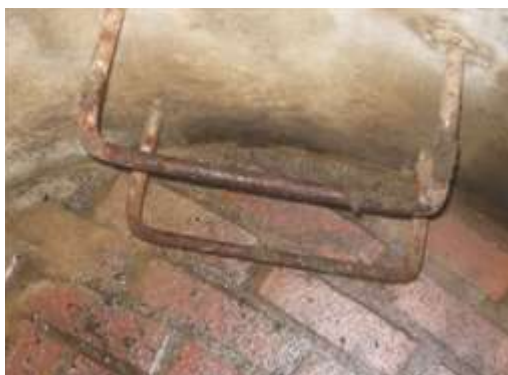
Defect 5

**Steps** Count: **2** Missing: **0** ☒ **Corroded**

bottom oxidized rungs

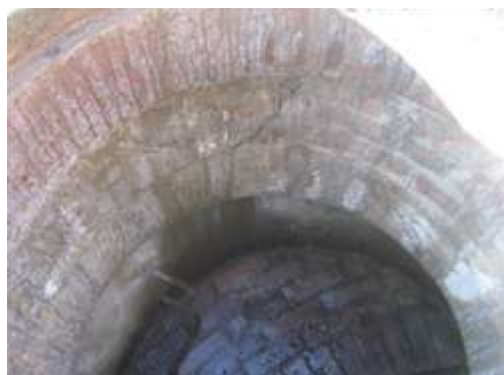
Defect 3

Condition: ☐ Sound ☒ **Cracked** ☐ Root Intrusion ☐ Loose Brick ☐ Deteriorated

cracked chimney and corbel

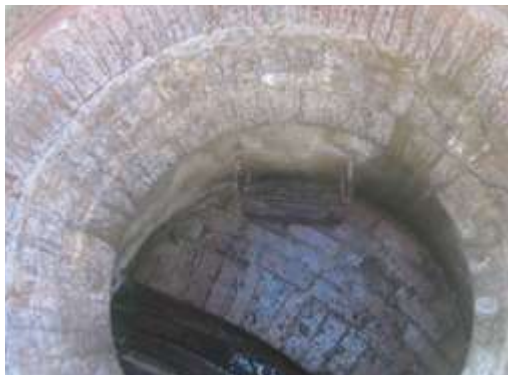
### Defect 2

**Frame** Offset: **0** (in.) Condition: ☐ Sound ☐ Cracked ☒ **Leaks**

infiltration lid/frame

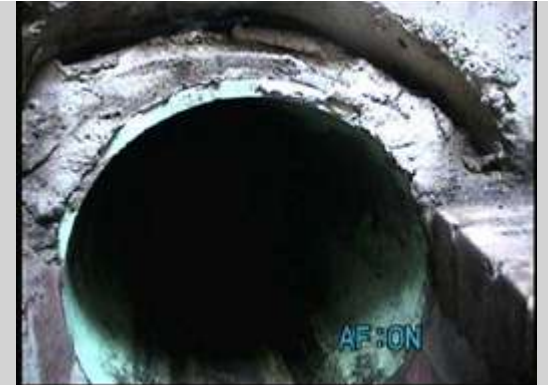
12 O'Clock Outflow

Pipe Height: **12** (in.) Rod and Bar (Angled)  
Pipe Material: **PVC** ☐ Pipe Lined  
Invert Depth: **5.63** (ft.) Flow Characteristics: **Slow**  
Deposits: ☒ None ☐ Mud ☐ Sludge ☐ Debris ☐ Grease  
Silt Depth: **0** (in.) Deposits Extent:  
Infiltration: **None** Pipe Seal Cond: **Sound**

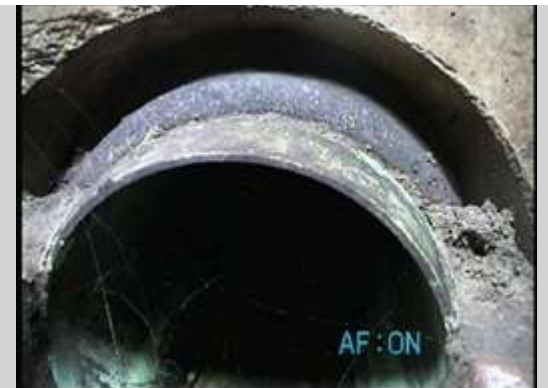
7 O'Clock Inflow

Pipe Height: **12** (in.) Rod and Bar (Angled)  
Pipe Material: **PVC** ☐ Pipe Lined  
Invert Depth: **5.53** (ft.) Flow Characteristics: **Slow**  
Deposits: ☒ None ☐ Mud ☐ Sludge ☐ Debris ☐ Grease  
Silt Depth: **0** (in.) Deposits Extent:  
Infiltration: **None** Pipe Seal Cond: **Sound**
